## Improving Cow Comfort through Proper Neck Rail Placement

By: Jeffrey Bewley, Ph.D.

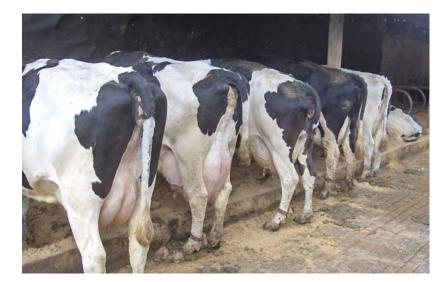
Figure 1. An example of "perching" with cows standing half in and half out of stalls. Perching may indicate that the neck rail should be moved.

As I have travelled across Kentucky these past few months, I have noticed quite a few herds with cow comfort limitations related to improper neck rail placement. The neck rail helps position the cow when she enters the stall or when she is standing in the stall before or after standing up. Additionally, the neck rail helps encourage cows to preserve lunge space and defecate in the manure alley. One way we can evaluate neck rail placement is by observing cows for perching behavior. "Perching" refers to the behavior when cows stand with their front feet in the stall and their rear feet in the alley behind the stall (Figure 1). Generally, this behavior indicates improper neck rail placement. If neck rails are too low, cows may also be hesitant to enter the stalls and have difficulty standing up. When the neck rail is in the proper position, cows will stand with all four feet placed squarely within the stall, level backs, and the top of their necks gently touching the neck rail (Figure 2).

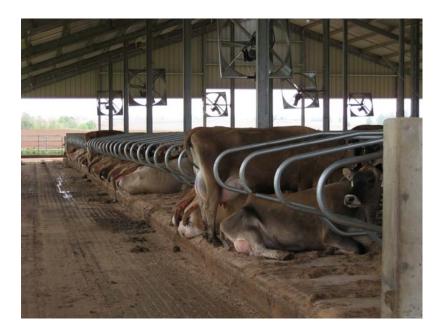
Figure 2. An example of well-designed freestalls. Notice that most cows are lying down and the two cows that are not lying are standing with their four feet squarely placed in the freestall.
